# Report on Assisted Travel at Belfast City Airport

**Consumer Council for Northern Ireland**

**25 September 2025**

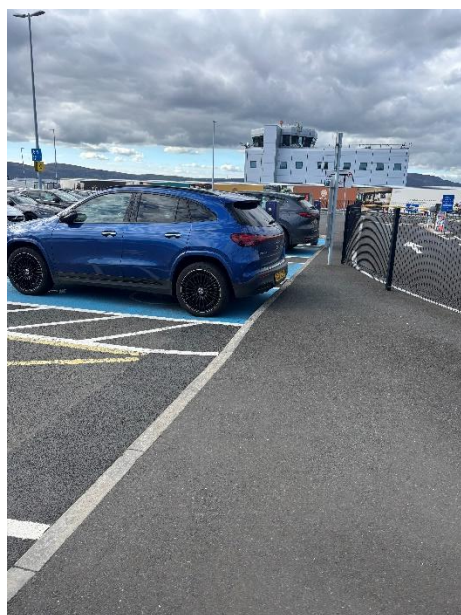
**Figure 1: EV Charging Bays**

The footway where the electric vehicle charging bays are located (figure 1) reduces in width significantly without a dropped kerb. This can make this section of the footway inaccessible for wheelchair users and others.

- Consider how the footway at the electric vehicle charging bays in the short stay car park can be redesigned to ensure everyone has safe access navigating from the car park to the airport building entrance.

1. Consider how the footway at the electric vehicle charging bays in the short stay car park can be redesigned to ensure everyone has safe access navigating from the car park to the airport building entrance.

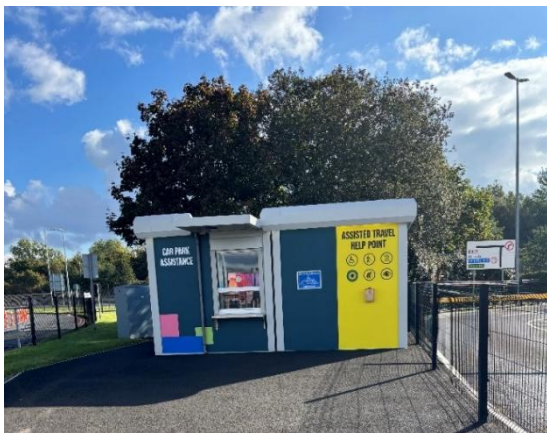
**Figure 2: Assistance point**

Participants noted the new assistance point (figure 2) is clearly visible within the carpark and is a significant improvement to the previous call point which was in the shelter. Staff confirmed the assistance point is always manned. Seating is not immediately available at the assistance point. The nearest seating is close by in the covered passenger waiting area (figure 3).

- Consider installing a sheltered seating area at the assistance point.
- Add arm rests to the second bench (figure 4) in the covered walkway so both are easily accessible.

6. Consider installing a sheltered seating area at the assistance point.
7. Add arm rests to the second bench (figure 4) in the covered walkway so both are easily accessible.

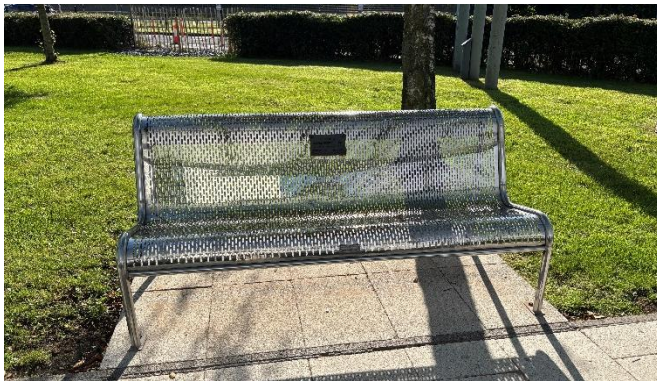
**Figure 4: Bench at walkway to entrance**

The covered walkway to the entrance of the airport building has two benches, one of which does not have arm rests making it less accessible (figure 4).

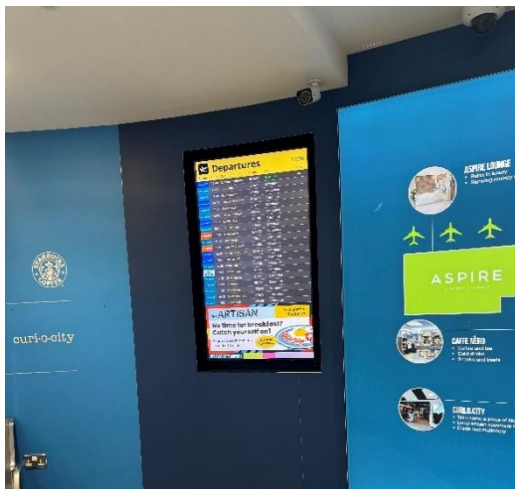
**Figure 6: Screen at top of stairs after security area**

Some flight information screens were small and difficult to read for example (figure 6) at top of stairs from security. However there are some good examples such as the information screen just through security.

- Address accessibility of elevators during next phase of refurbishment.
- Consider increasing the number of larger size flight information screens.

11. Address accessibility of elevators during next phase of refurbishment.
12. Consider increasing the number of larger size flight information screens.

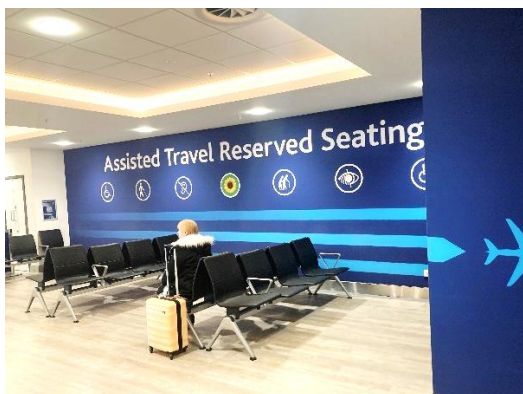
**Figure 8: Assisted travel seating area**

Airport staff noted the removal of ribbon cordons and the addition of panels outlining the Assisted Travel Reserved Seating area (figure 8). The forum praised this change but also recognised the importance ensuring they are not occupied by passengers who do not require them.

- Consider provision of a quiet area. Given space limitations this could be considered in future refurbishment.

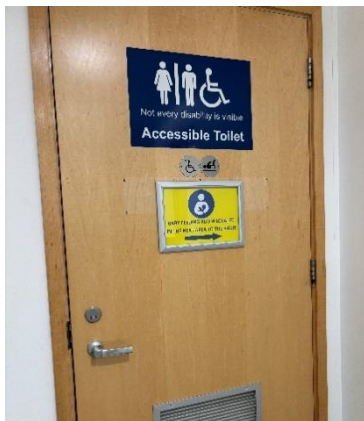
**Figure 9: Accessible Toilets**

Forum members advised that it was sometimes difficult to see if the accessible toilet was occupied as the "engaged" sign was very small. It was also noted that there is no Braille on the door of the accessible toilet next to the ladies' toilets (figure 9).

- Add Braille to the accessible toilet door next to the ladies' toilets. (figure 9).
- Provide an information leaflet outlining locations of amenities within bathrooms.
- Enhance the size of the vacant/occupied sign on toilet doors or provide alternative indicators to increase visibility.
- Consider addressing provision of toilet access at gate areas in future refurbishment.
- Amend positioning of feedback devices to a height accessible for all.

17. Add Braille to the accessible toilet door next to the ladies' toilets (figure 9).
18. Provide an information leaflet outlining locations of amenities within bathrooms.

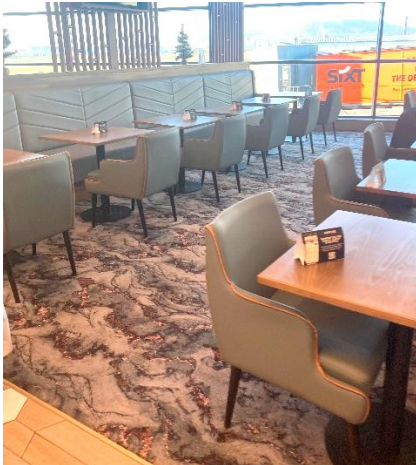
**Figure 10: Aspire Lounge area**

Forum members noted that the information screens in the Aspire Lounge area were difficult to read. Additionally, it was advised that the private booths were very small and carpeted which is not ideal for wheelchair users (figure 10).

- Consider larger information screens/text in Aspire Lounge.
- Increasing accessibility to booths by adding tactile flooring.
- Accessible reserved booths for those who require it.
- Expand the amenities in the accessible area to provide more independent access for passengers.

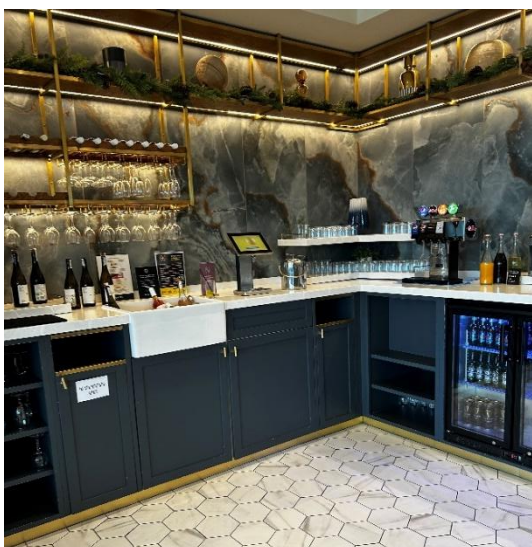
**Figure 11: Aspire Lounge bar area**

The Aspire Lounge bar area (figure 11) is built for independent access to glasses and drinks however, participants considered the height of the countertops makes it out of reach for wheelchair users. Alternatively, table service is available for those who require it. An accessible area to the right of the main bar, currently containing a single coffee machine and a fridge with milks on a lower bench, could be more effectively utilised.
