# **Report on Assisted Travel at Belfast City Airport**

**Consumer Council for Northern Ireland**

**09 September 2025**

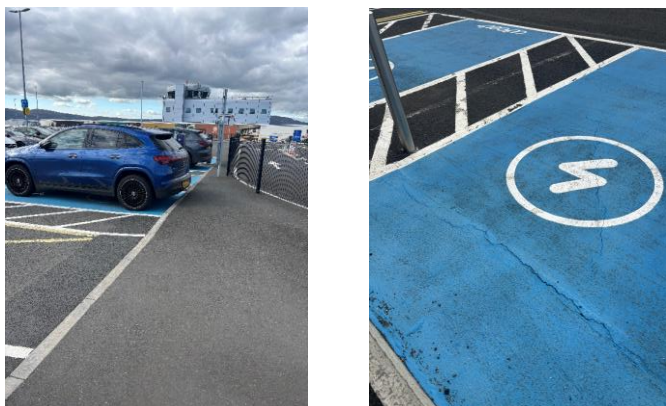
**Figure 1: Electric Vehicle Charging Bays**

The electric vehicle charging bays in the short stay car park are marked out in blue and white (Figure 1). This is the same colour scheme used to denote blue badge parking bays which can be confusing. The group considered that green is a commonly recognised colour for electric vehicle charging bays.

- Consider providing car park pricing as displayed at the entry barrier before this point, for example online.
- Change the colour of electric vehicle parking bays to green to differentiate them from blue badge bays.

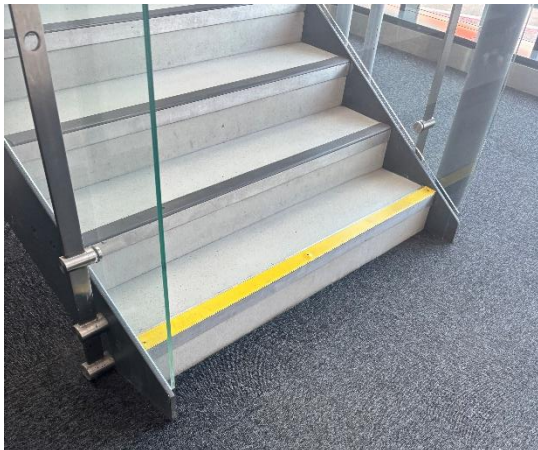
**Figure 2: Yellow Strip on Staircase**

The top and bottom steps on the staircase from security to the shopping area and departures would benefit from having markers added to improve visibility. Adding a yellow strip would be consistent with other staircases throughout the airport (see Figure 2).

- Enhance disability awareness training and ensure refresher training for airport security staff including sight loss awareness and sighted guide training.
- Consider how to increase knowledge of the availability of an alternative route to departures to those who would find it most beneficial.
- Ensure there is a yellow strip at the top and bottom of the staircase from the security area.

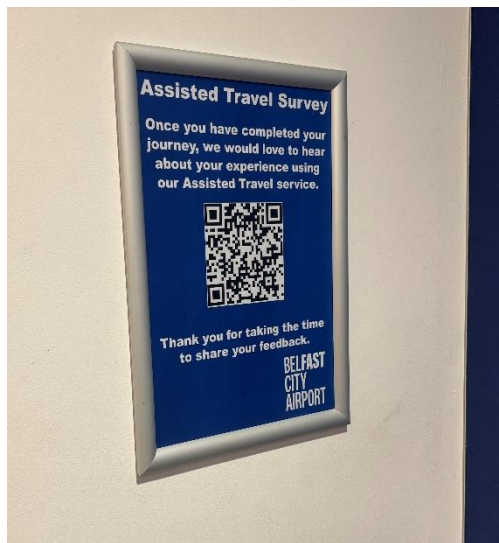
**Figure 3: Assisted Travel Survey Sign**

The airport actively seeks to raise awareness of the assisted travel survey. Signage providing information about accessing the assisted travel survey was clearly visible in the assisted travel area (Figure 3). In addition, staff can add email contacts of service users in the new system CCS use for assisted travel services internal booking procedures which generates an automatic email inviting responses to the survey.

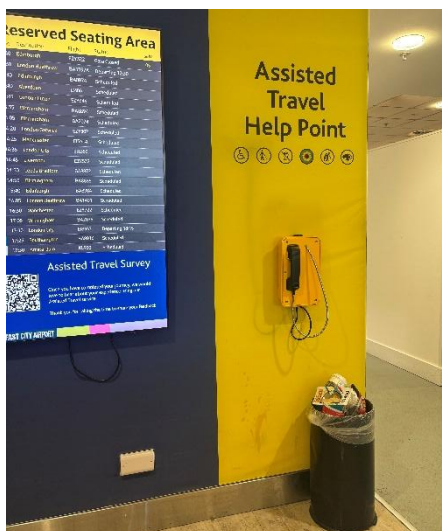
**Figure 4: Assisted Travel Help Point**

The bin below the telephone at the Assisted Travel Help Point (Figure 4) should be relocated to improve accessibility.

- Relocate bin from below the telephone at the Assisted Travel Help Point.

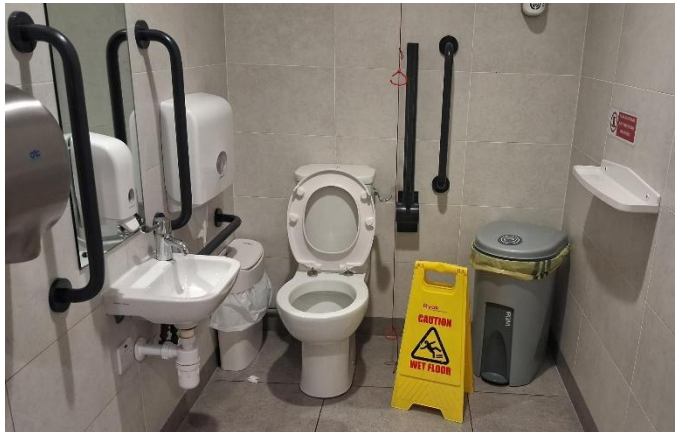
**Figure 5: Accessible Toilet**

There were various examples throughout the airport of obstructions in accessible toilets such as bins and wet floor signs (Figure 5). These are barriers for a wheelchair user transferring to the toilet. It was proposed that providing a means to fix the bin in a suitable location and reminding cleaning staff of correct bin placement could help.

- Ensure all emergency pull cords in toilets meet current standards (BS 8300 Design of an accessible and inclusive built environment - Buildings).
- Ensure bins and other items such as wet floor signs do not obstruct access to the toilet.
- Relocate the assistance rail beside the wash hand basin in the Changing Places facility to the other side or install one which is adjustable.
- Consider adding signage on accessible toilet doors to indicate transfer side for wheelchair users.
- Consider the possibility of making adjustments within the family toilet in departures so that it could serve as a flexible disabled/family/baby change facility.

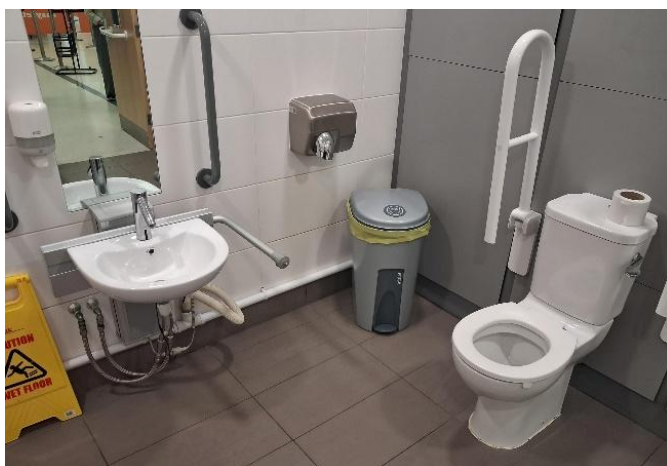
**Figure 6: Changing Places Facility**

In the Changing Places facility the assistance rail attached to the wash hand basin protrudes which prevents a wheelchair user from manoeuvring into place beside the toilet (Figure 6). Members noted not everyone transfers from the same side of the toilet. Potential solutions proposed included moving the rail to the other side of the wash hand basin or installing an adjustable assistance rail which could be raised against the wall. In addition signage indicating the transfer side such as that shown in Figure 7 would be helpful.

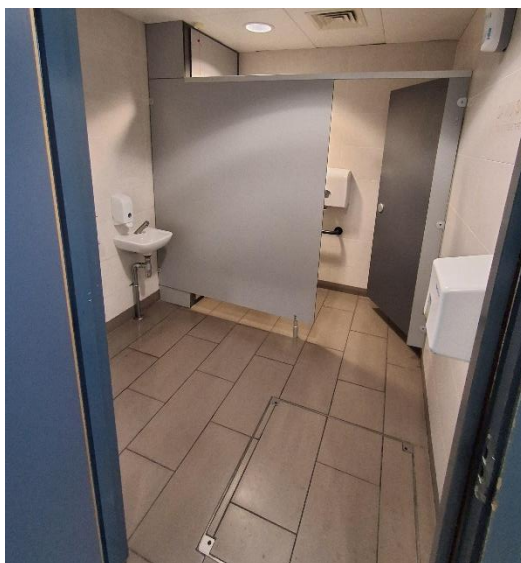
**Figure 8: Family toilet / baby change**

Participants expressed a view that the family toilet facility and baby change in departures (Figure 8) adjacent to the reserved seating area could potentially also serve as an alternative disabled toilet if the door and screening beside the toilet was removed.
